LOK-N-BLOK

Test Report Load Test of Home Show Booth Mockup

Date of Testing: January 16 through January 18, 2018 Date of Report: September 10, 2019 WJE No. 2017.6646.0

Load Test of Home Show Booth Mockup

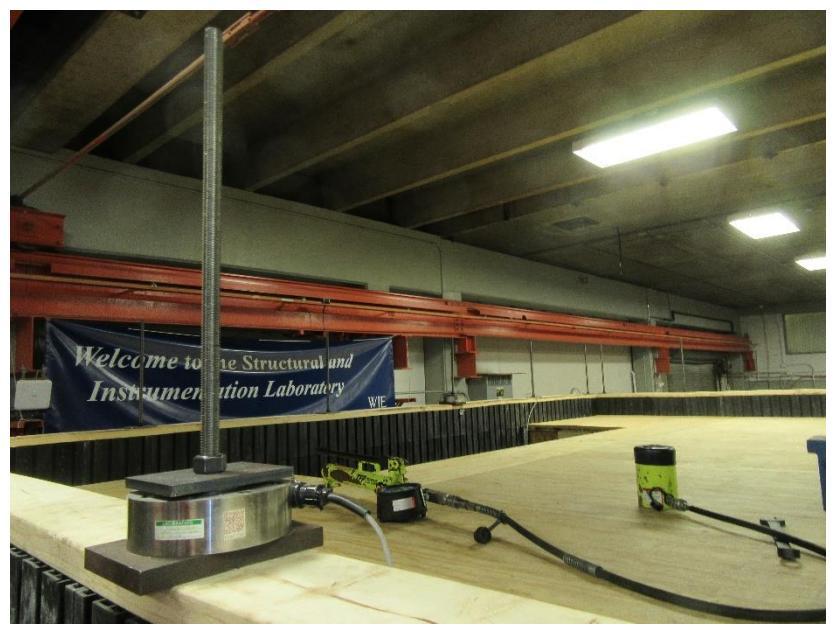
The tensile forces in two of the twenty steel tie-down rods, one on a short wall supporting the floor joists and one on a long wall (Figure 12), were monitored continuously using 20,000-pound load cells. Vertical displacements of the walls and joists were also monitored continuously using fifteen electronic displacement transducers (stringpots) attached at various locations throughout the booth. Wires attached to the walls and joists were extended downward and attached to the displacement transducers on the floor below. Figure 13 shows a wire attached to an angle mounted to a wall and a wire attached to an eye-hook screwed into the bottom flange of a joist near a joist hanger. Figure 14 shows two displacement transducers installed on the floor below. A plan view of the booth with instrumentation locations is shown in Appendix B. Inspections for signs of distress in the walls and floor structure were made during the load test, and at the end of the 45-hour holding period.

Figure 12. Load Cell 3 on south bearing wall, tensioning equipment on plywood decking.

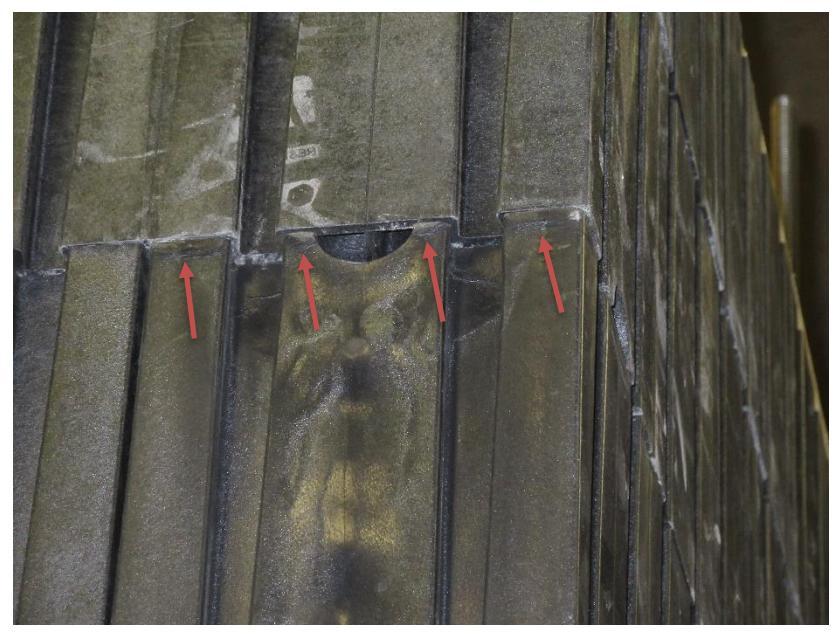
The only evidence of block distress observed following the load test was a minor amount of crushing or buckling of the top edge wall of one of the upper corner blocks (Figure 18). No other distress was observed in the block in question. Upon further review, it was determined that the crushing observed had very likely not occurred during the load test. Our client, who supplied the blocks, indicated that individual blocks which had been previously used for compression testing may have been included on the pallets with new blocks. Upon examining the pallets, we found several other blocks which were not used for the load test, or any other test performed by WJE, which exhibited similar crushing at the block edge, indicating they had been used for compression testing previously performed by others. We believe that due to the minor amount of distress, the condition was not identified during the assembly of the booth and the block was used inadvertently.

This scenario appears likely for several other reasons. While the compressive stress in the blocks in this region was likely greater than in a typical wall section due to the placement of two pre-tensioned steel rods near the corner, this loading condition was similar for all corners of the booth and similar distress was not observed at any other location. In addition, in our preliminary block compression tests, the upper section of the block sidewalls did not exhibit similar distress until two to three times the load estimated to have been applied to the booth corner blocks during the load test. Further, the second-floor structure was supported on the inside face of the blocks, and if crushing were to occur the inside block face below the connection of the second-floor structure would seem to be a more likely location. Lastly, the tension in the adjacent rods was not affected. Had crushing occurred during the load test, a decrease in rod tension greater than other rods would have been expected due to the deformation of the block.

Figure 18. Local block exterior wall buckling/crushing at upper northeast corner block.

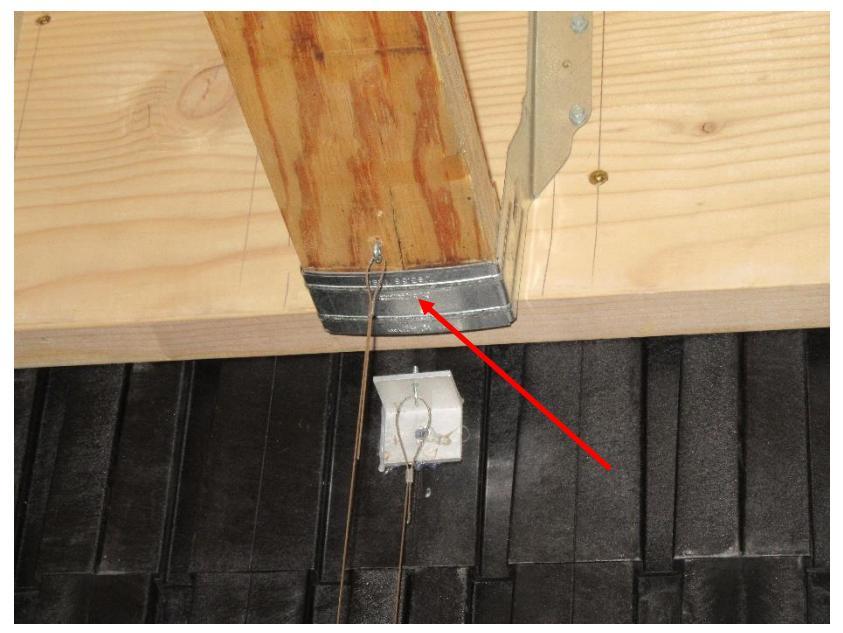
Figure 19. Local bending of single Type 2 joist hanger bottom plate (red arrow) during load test.

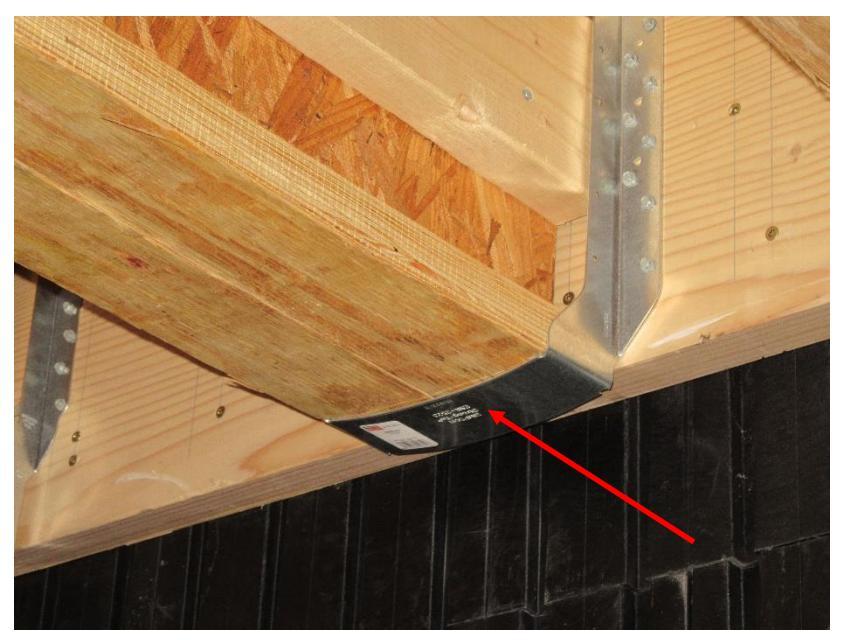
The measured rebound for all tested structural members, except for the double joist hanger, is greater than 75 percent. The rebound for the double joist hanger is 74 percent, slightly less than the IBC-prescribed limit. However, our analysis of the difference between the initial "immediate" deflection and the time-dependent deflection which occurred over the duration of the test suggests that had the load test been stopped at 24 hours, per the IBC load test criteria, the rebound percentage would likely have been greater than 75 percent. Therefore, in our opinion, the test results for the double joist hangers is the result of local bending of the joist hanger bottom plate (Figures 19 and 20). This was more pronounced for the double joist hangers, but was observed for the single joist hangers as well. Although this behavior does impact the evaluation of the booth per the IBC load test criteria, it is not related to the performance of the block walls or the attachment of the joist hangers to the walls.

Figure 20. Local bending of double Type 2 joist hanger bottom plate (red arrow) during load test.
